Listeria monocytogenes – Management in Dairy Factories

This Note provides a background on why *Listeria monocytogenes* is a concern for dairy manufacturers, and offers practical measures to prevent product contaminations, or manage them should they occur.

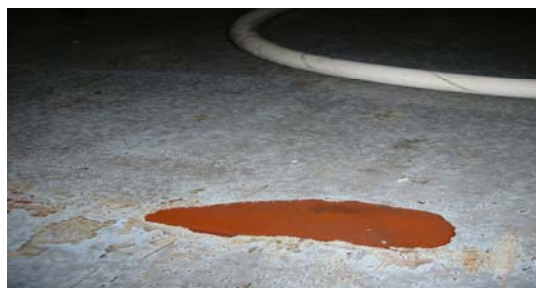
Floors: Effective floor sealing is essential, particularly where equipment is or has been mounted on the floor. Any damage must be repaired promptly in order to prevent bacterial colonisation.

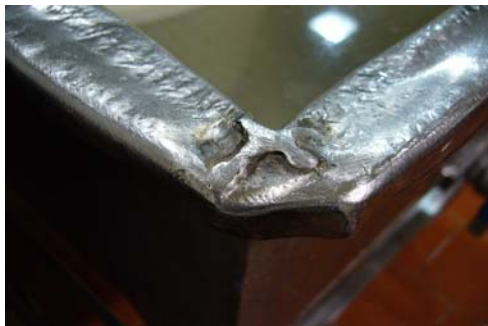
Jacketed vats: Jacketed vats can be damaged or pitted on internal surfaces and holes may not be visible to the naked eye. Leak detection dyes are useful in such cases. External corrosion of vats can also allow contamination with product and organisms, which may be difficult to trace and remove.

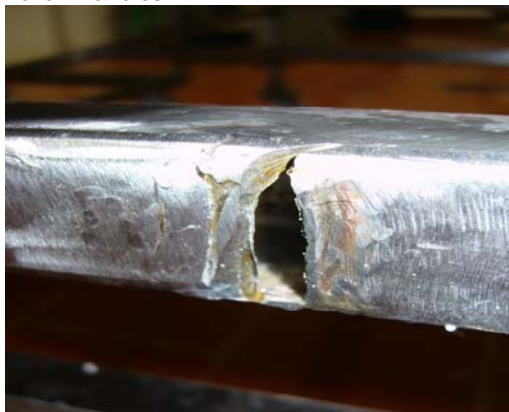
Enclosed support frames & other hollow equipment: When damaged or ineffectively sealed, enclosed support frames can become impossible to clean if internally contaminated. They have been known to cause on-going intermittent contamination through leakage onto exposed product. Avoid this tube structure where possible. Alternatively, ensure it is totally sealed, or can be effectively cleaned and drained. Any other equipment that is of hollow construction can similarly be a potential site for microbial contamination, such as conveyor rollers, agitator shafts and manual equipment with hollow handles.
