# Listeria monocytogenes – management in dairy factories

This technical information note explains why *Listeria monocytogenes* is a concern for dairy manufacturers, and offers practical measures to prevent product contaminations, or manage them should they occur.

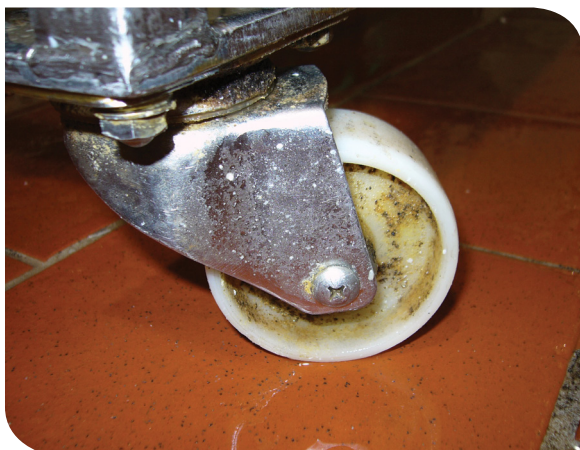
Example of contamination source – trolley wheels

Similarly, equipment can also transfer *Listeria* into production areas. Trolleys, forklifts, pallets, containers (particularly cardboard) are all possible contamination sources.<sup>8</sup>

**Trolley wheels:** Often overlooked in cleaning, trolley wheels can combine product, grease, moisture and soil, becoming a breeding ground for *Listeria*. Do not use high pressure water if cleaning them in production areas, as aerosols will be produced.

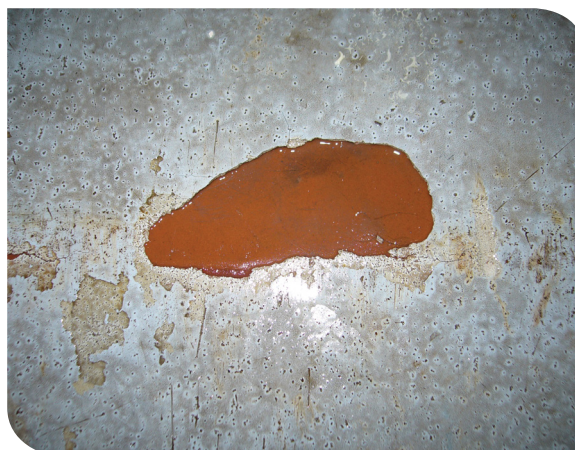
Example of contamination source – damaged flooring

**Floors:** Effective floor sealing is essential, particularly where equipment is or has been mounted on the floor. Any damage must be repaired promptly in order to prevent bacterial colonisation.

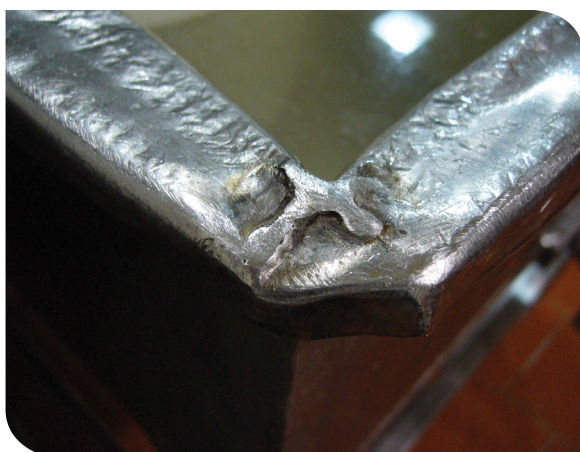
Example of contamination source – damaged vat

**Jacketed vats:** Jacketed vats can be damaged or pitted on internal surfaces and holes may not be visible to the naked eye. Leak detection dyes are useful in such cases. External corrosion of vats can also allow contamination with product and organisms, which may be difficult to trace and remove.

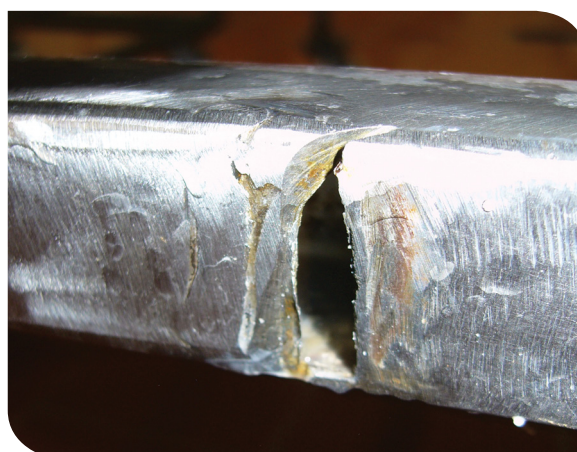
Example of contamination source – enclosed structures

When damaged or ineffectively sealed, enclosed support frames can become impossible to clean if internally contaminated. They have been known to cause on-going intermittent contamination through leakage onto exposed product. Avoid this tube structure where possible.

Alternatively, ensure it is totally sealed, or can be effectively cleaned and drained. Any other equipment that is of hollow construction can similarly be a potential site for microbial contamination, such as conveyor rollers, agitator shafts and manual equipment with hollow handles.
